# iRADVC7000/9000s

- 1.Coating error
- 2.Coating failure at rear side of sleeve
- 3.Toner leaking

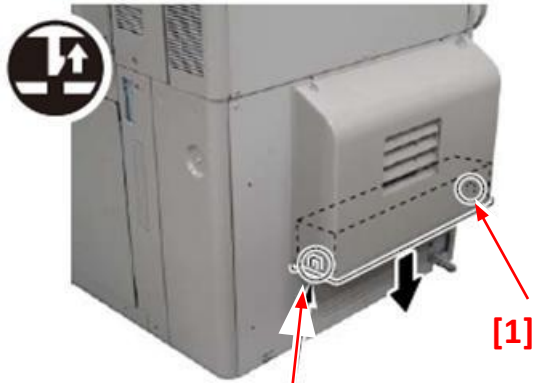
[1] Claw

**A. As the measure against the temperature rise inside the machine, place the machine far away from the wall as much as possible, and replace the 3 filters regularly.**

- Distance between the rear side of machine and the wall: preferably 10cm or more
- Filter (3 filters) replacement intervals: every 500K images

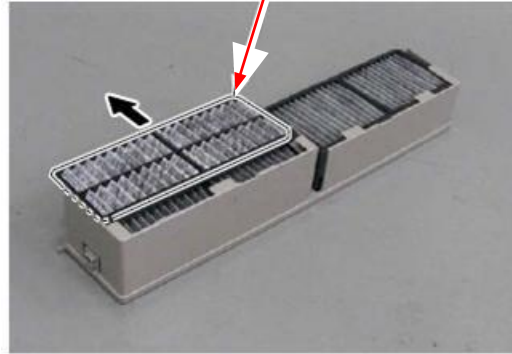
[2] Dust filter (FL2-8946)

Replacement interval: every 500K images  
Replacement interval: every 500K images

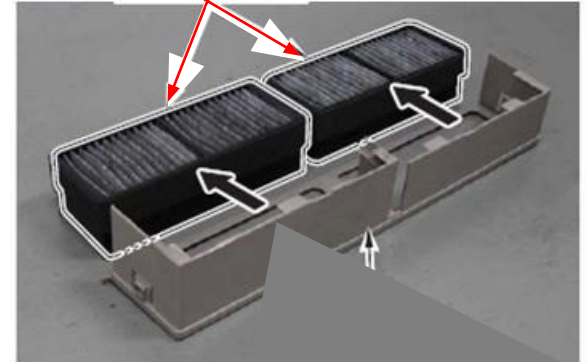
[3] Ozone filter (FL3-4101)

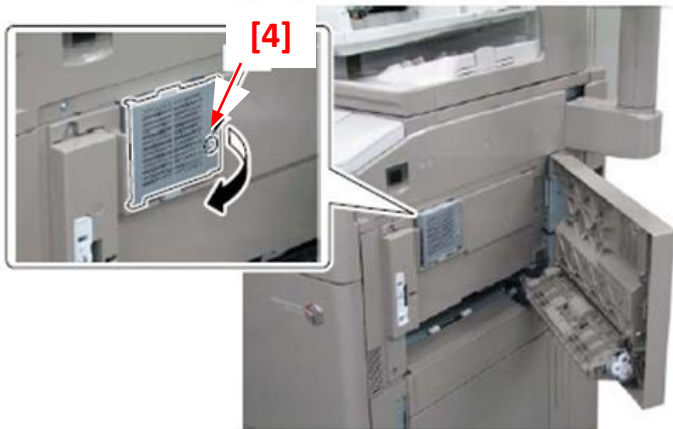
[4] Fixing screw

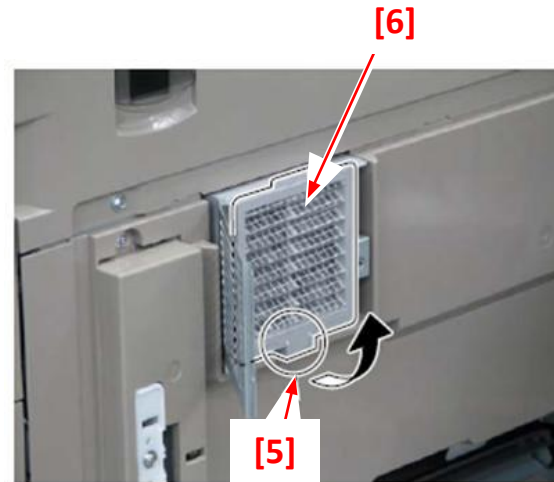
[6]

[5]

[5] Finger recess

[6] Dust filter (FL2-0439)

Replacement interval: every 500K images

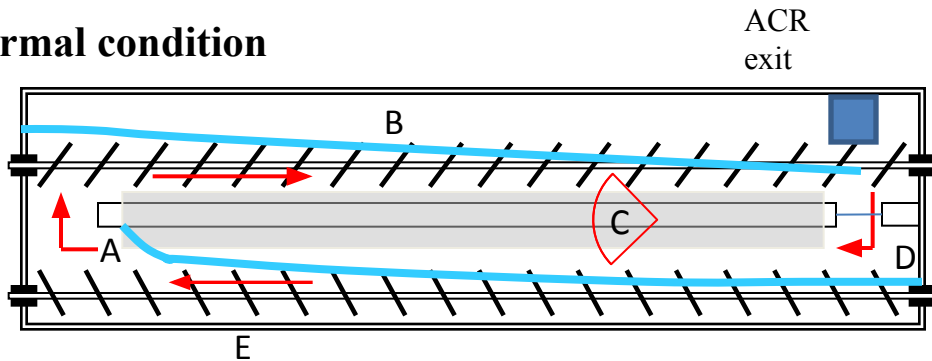
**1. Normal condition**

**If the developer circulation is normal,** the developer exists in the distribution shown in the dotted line.

Toner flows as the **arrows** show.

A: Pump from bottom up.

B: Being delivered from front to rear.

C: A portion drops according to the sleeve cylinder.

D: Drops.

E: Being delivered from rear to front.

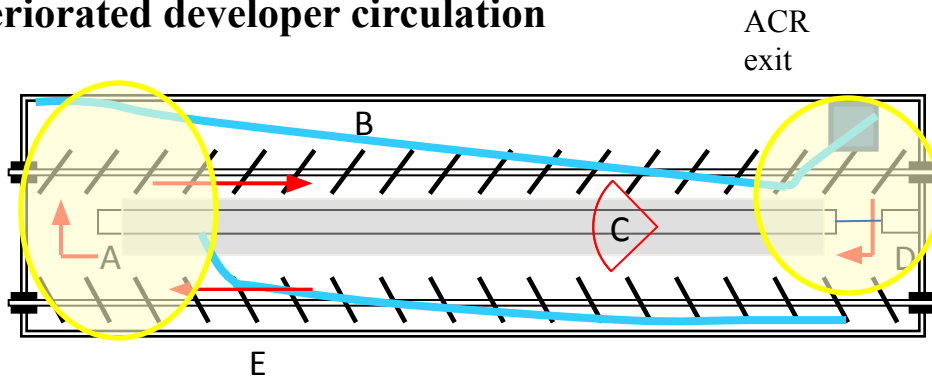
**2. Deteriorated developer circulation**

**If the developer circulation is deteriorated,** the developer exists in the distribution shown in the dotted line.

Poor developer flow tends to occur at 2 points.

Front/A-B front: Developer accumulates and hardly flows.

Rear/D: Developer accumulates and hardly drops.

-If developer remains unmoving in the front/A-B front side, developer leakage at the front or developer leakage due to increased amount of toner may occur.

-If developer remains unmoving in the rear (D) side, excess developer is discharged, and the amount of toner inside the developing assembly may decrease.

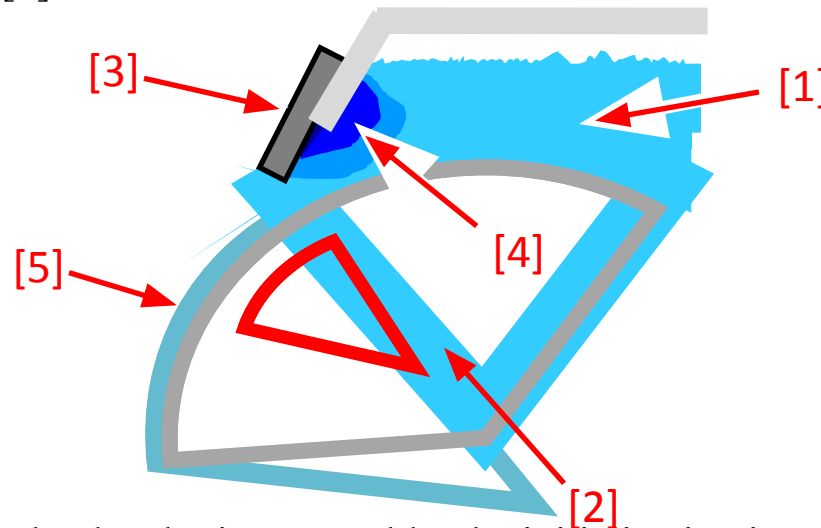
When a large number of originals with a low density is printed, toner [1] is not consumed and turns into agglomeration [4] in a space between the developing sleeve [2] and the blade [3], consequently causing coating failure [5] on the sleeve.

- Replace the toner bottle of affected color and output 200 pages of PG10 images to discharge the toner agglomeration.
- Remove the foreign material with a special tool.

Output 10 pages of PG10 images so that the initial/post rotation will be executed.

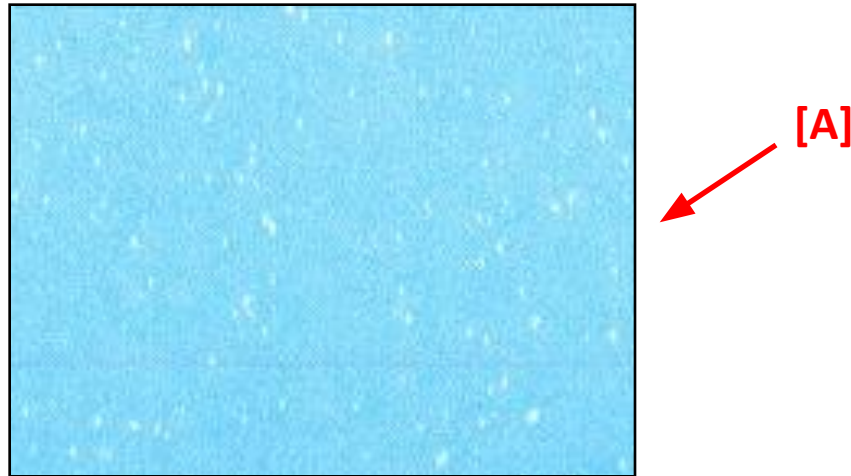
P-1 White spots image

In case of less color jobs, white spots may appear on image due to shortage of the toner amount in the color developing assemblies of Y, M and C is reduced.

When there are less color jobs, the toner supply control of the color developing assembly does not operate as expected resulting in toner supply shortage.

[A] White spots (2 - 3mm in diameter)

Upgrading the Dcon version to v62.02 to modifies the toner supply control failure.

Upgrade to the following software if the above symptom occurs.

Dcon v 62.02

STEP 2: Making prints/copies of solid PG image in the affected color until the white spots disappear.
