# iRADVC7000/9000s

- 1.Coating error
- 2.Coating failure at rear side of sleeve
- 3.Toner leaking

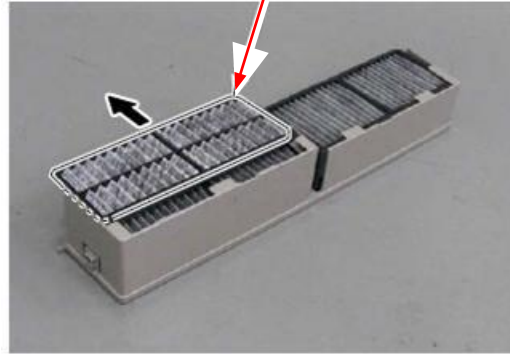
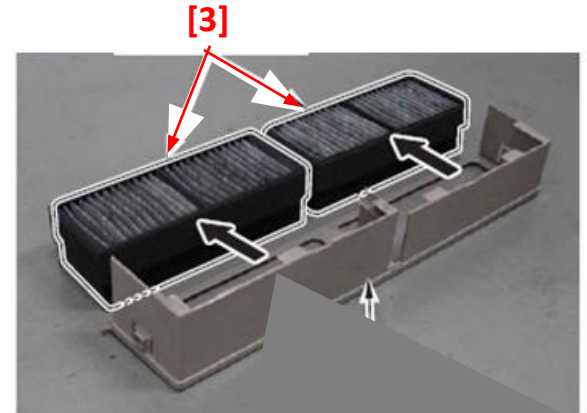
### 3 filters that needs to be replaced regularly

[1] Claw

[2] Dust filter (FL2-8946)

[3] Ozone filter (FL3-4101)

Replacement interval: every 500K images  
Replacement interval: every 500K images

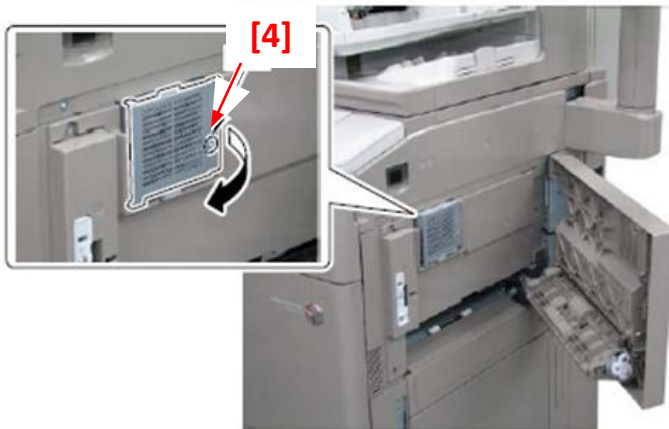
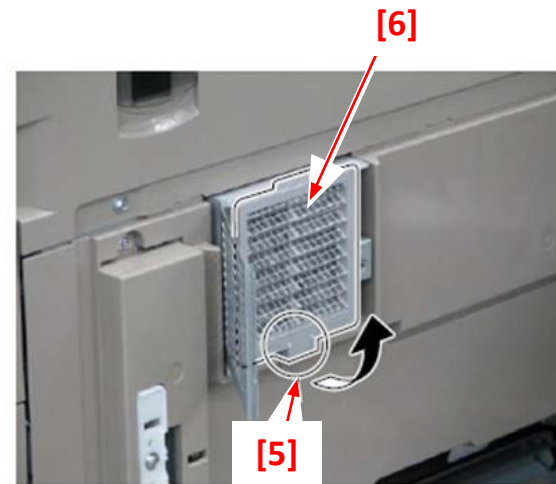
[4] Fixing screw

[5] Finger recess

[6] Dust filter (FL2-0439)

Replacement interval: every 500K images

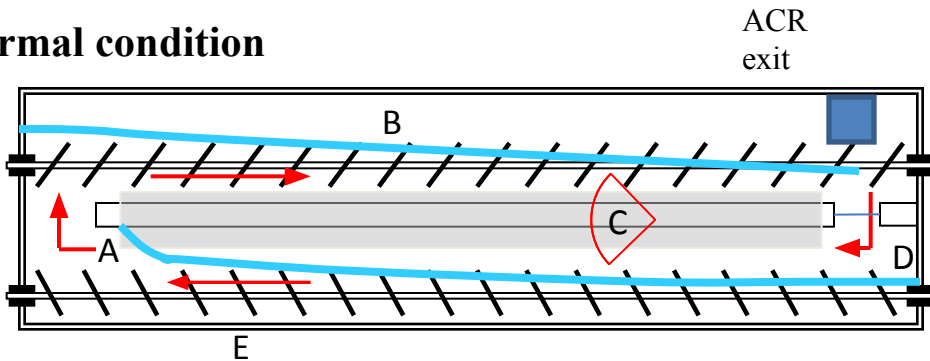
**1. Normal condition**

**If the developer circulation is normal,** the developer exists in the distribution shown in the dotted line.

Toner flows as the **arrows** show.

A: Pump from bottom up.

B: Being delivered from front to rear.

C: A portion drops according to the sleeve cylinder.

D: Drops.

E: Being delivered from rear to front.

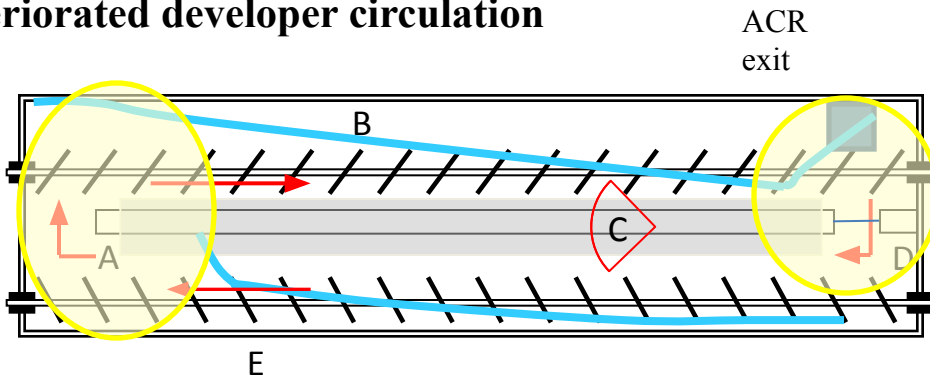
**2. Deteriorated developer circulation**

**If the developer circulation is deteriorated,** the developer exists in the distribution shown in the dotted line.

Poor developer flow tends to occur at 2 points.

Front/A-B front: Developer accumulates and hardly flows.

Rear/D: Developer accumulates and hardly drops.

-If developer remains unmoving in the front/A-B front side, developer leakage at the front or developer leakage due to increased amount of toner may occur.

-If developer remains unmoving in the rear (D) side, excess developer is discharged, and the amount of toner inside the developing assembly may decrease.
