# iRADVC7000/9000s

- 1.Coating error
- 2.Coating failure at rear side of sleeve
- 3.Toner leaking

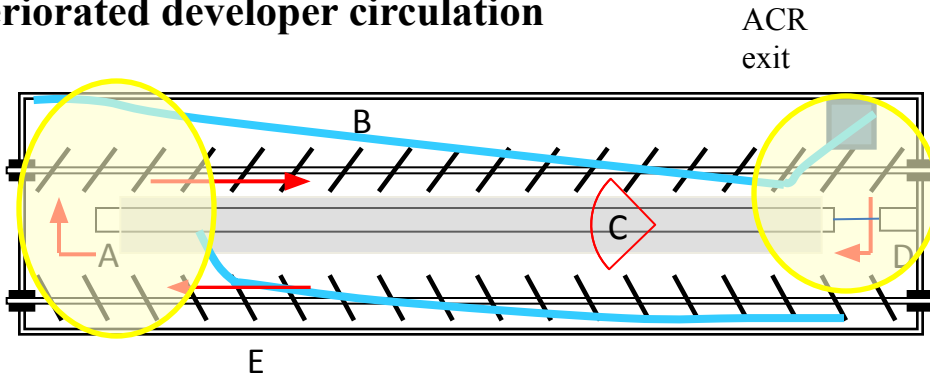
**2. Deteriorated developer circulation**

**If the developer circulation is deteriorated,** the developer exists in the distribution shown in the dotted line.

Poor developer flow tends to occur at 2 points.

Front/A-B front: Developer accumulates and hardly flows.

Rear/D: Developer accumulates and hardly drops.

-If developer remains unmoving in the front/A-B front side, developer leakage at the front or developer leakage due to increased amount of toner may occur.

-If developer remains unmoving in the rear (D) side, excess developer is discharged, and the amount of toner inside the developing assembly may decrease.
