# THINGS “NOT-TO-DO”

THESE PROCEDURES ARE SUITABLE FOR  
PRIMUS EPIC LOAD 21

**EMBRAER 170/190**

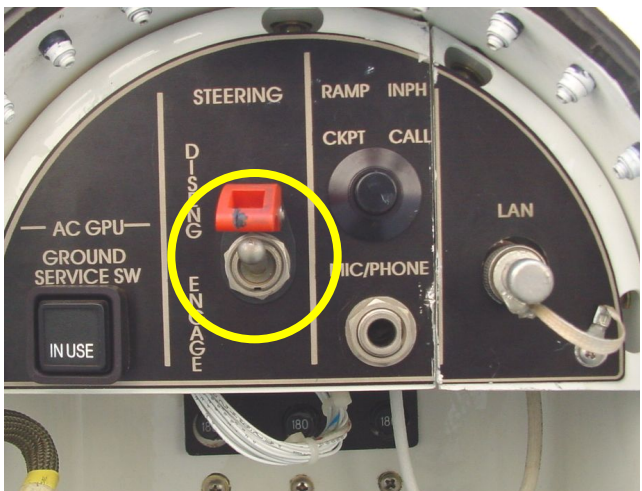
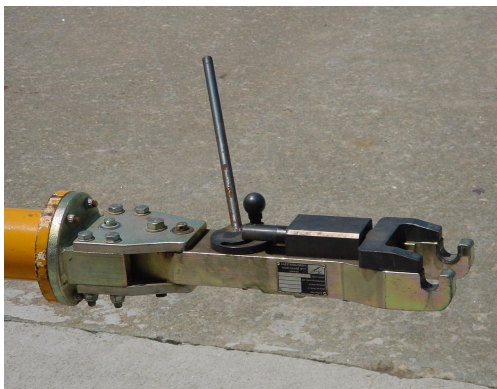
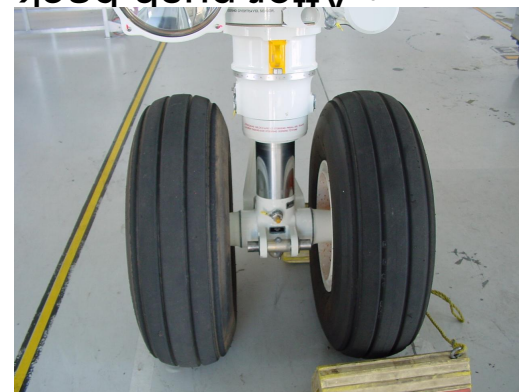
- After push back or towing procedure is completed:
- **DO NOT: set the external STEERING switch to ENGAGE position before disconnect the towbar assy from NLG.**
- Note 1: It could lead the STEER system to a "fail-safe" mode, and the STEER FAIL appears on the EICAS display.
- Note 2: A power reset is necessary to clear the message
- **RIGHT PROCEDURE: Remove the towbar from the NLG, THEN set the STEERING switch to ENGAGE position.**

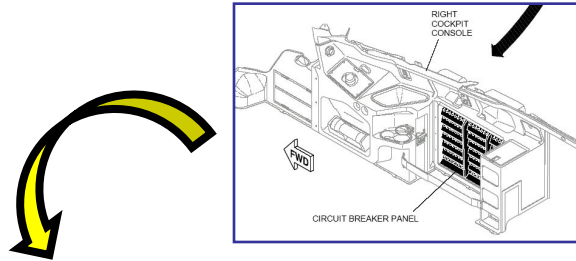
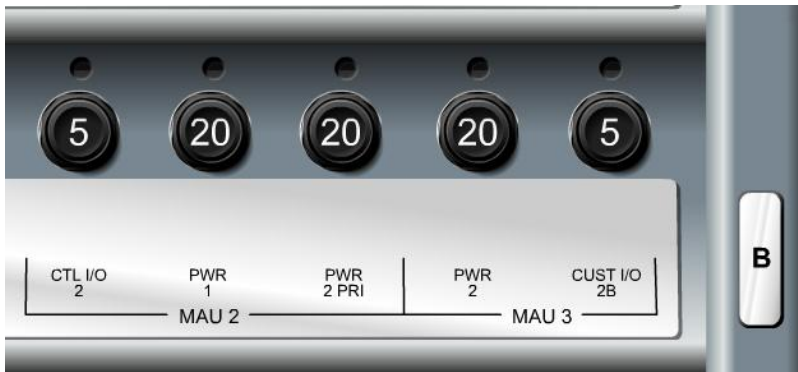
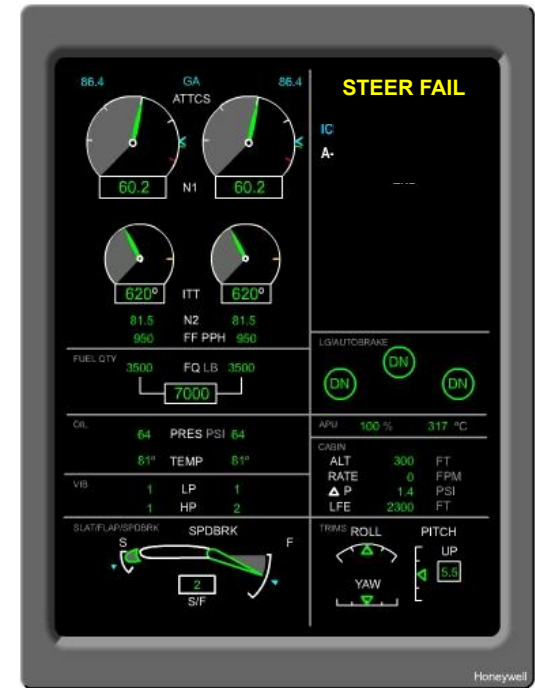
**MSGs: AVNX MAU 2A FAIL, STEER FAIL, FMS 1 FAIL and AFCS FAULT will be presented on EICAS.**

# PROCEDURE TO CLEAR "STEER FAIL" MSG ACD SNL AND OB:

**MAU 2 PWR 1 CB (B-25).....PULL**

**MAU 2 PWR 1 CB (B-25).....PUSH**

**MSGs: AVNX MAU 2A FAIL, STEER FAIL, FMS 1 FAIL and AFCS FAULT will be cleared from EICAS**

**REF: SNL 170-32-0014R00 and OB-170-003-05-Rev-01**

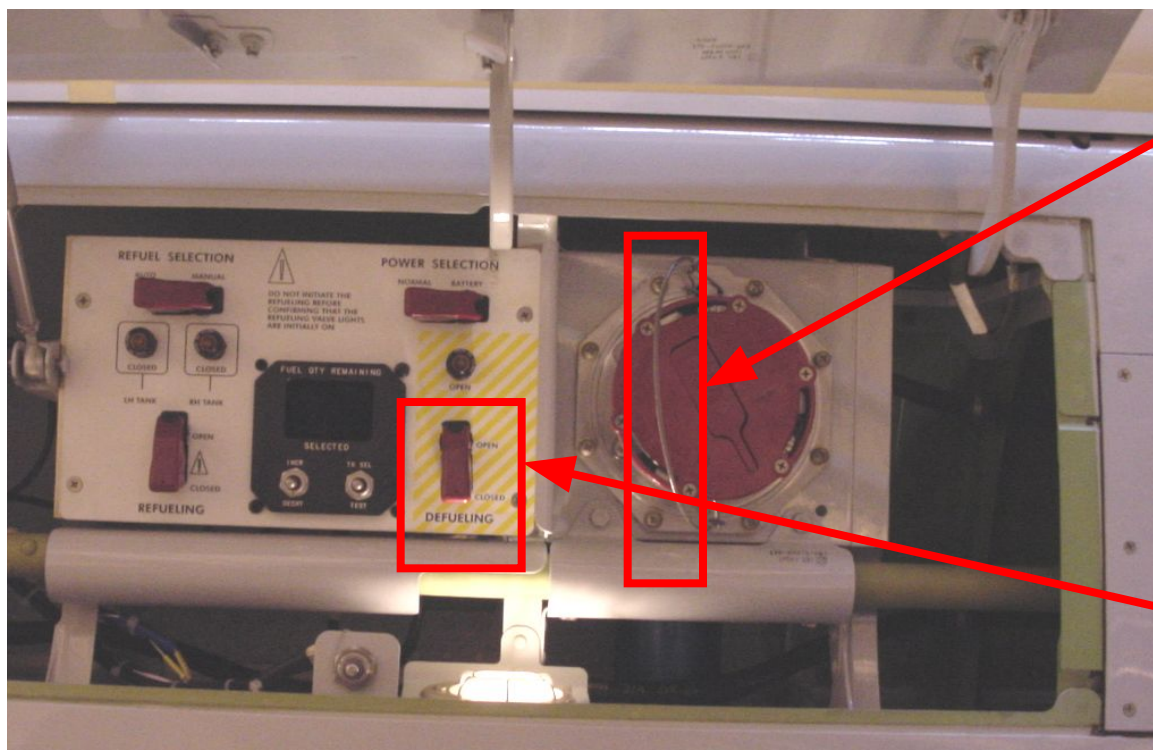
- **DO NOT:** Remove the fuel cap lanyard (refer to SB 170-28-0004) during the pressure refueling procedure.
- **DO NOT:** select the defueling switch to OPEN during the pressure refueling procedure (SNL 170-73-0007)

**DO NOT REMOVE**

**DO NOT SET TO OPEN WHILE REFUELING**

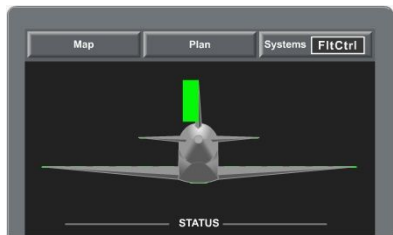
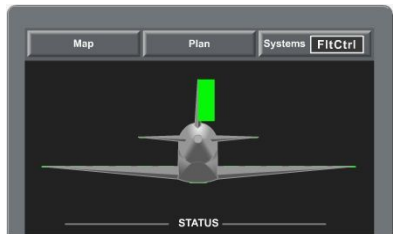
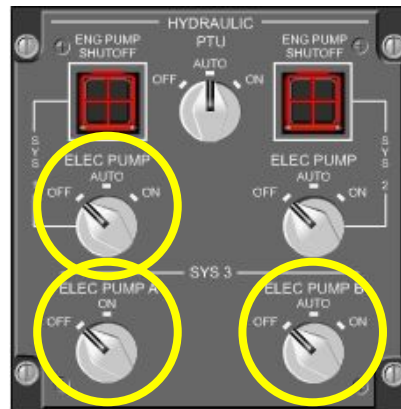
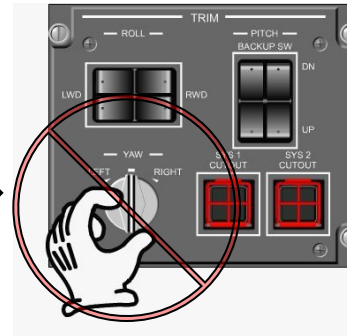
EICAS DISPLAY

- **DO NOT: trim the rudder with the surface deflected while the associated hydraulic systems (#1 and #3) are depressurized.**
  - Note 1: Doing that, a message **FLT CTRL NO DISPATCH** may be presented on EICAS display. An associated maintenance message **RUDDER PERFORMANCE FAULT** (fault code 27030553FCS) may be displayed on CMC active faults.
  - Note 2: In order to avoid this scenario, make sure that the **YAW TRIM** (confirm on EICAS display) is neutral before pressurize the hydraulic systems.

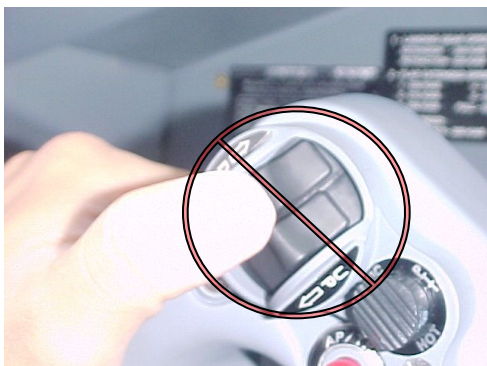
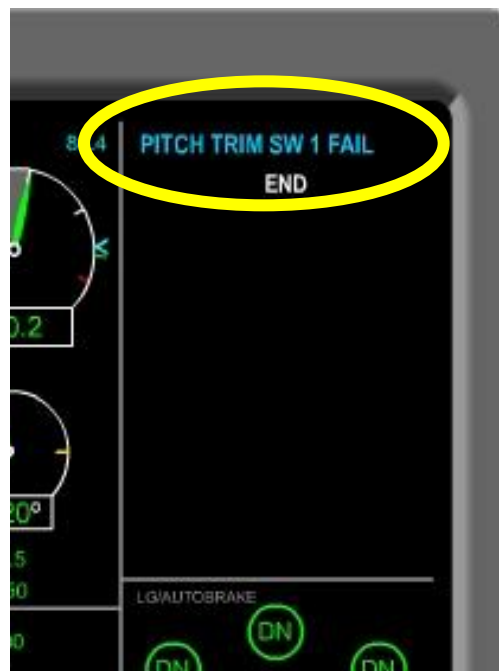
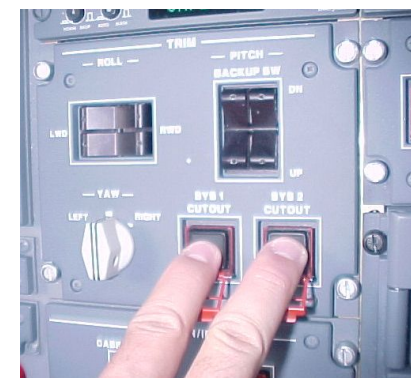
### EICAS DISPLAY

- **DO NOT: command only one pitch trim switch.**
- Note 1: Doing that, a message **PITCH TRIM SW 1 FAIL / PITCH TRIM SW 2 FAIL** or **PITCH TRIM BKUP FAIL** will be presented on EICAS display.
- Note 2: To clear these messages it is necessary to cycle both Cut-Out switches.

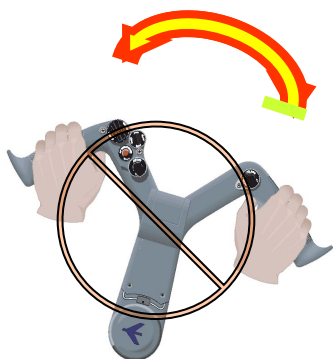
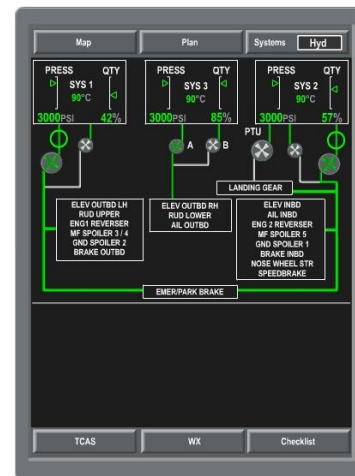
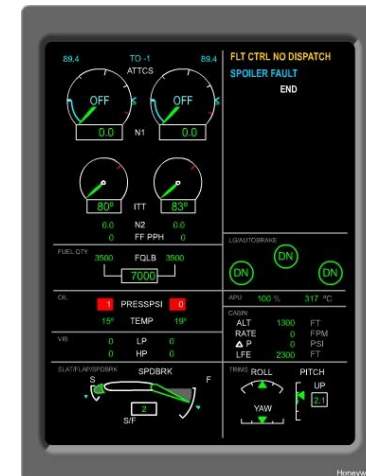
- **DO NOT: cycle the control wheels to speed up the hydraulic systems bleed, with hydraulics 1 and 2 OFF.**
- **Note 1:** Doing that the multi-function spoiler panels may not fully stow, causing a disagreement between the control wheel position and the surface position. If the aircraft is powered down and powered up with any disagreement the message **SPOILER FAULT** will be presented on EICAS display.
- **Note 2:** To clear the SPOILER FAULT message it is necessary to turn **“ON”** the hydraulic systems 1 and 2.

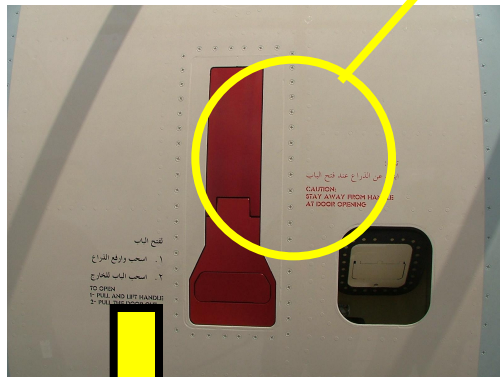
- **DO NOT: OPEN THE PASSENGER DOOR WITH THE FLAP VENT VALVE OPENED.**
  - Note 1: Doing this, there's a risk of deploying the escape slide.
  - Note 2: If the Flap Vent Valve is opened, first close it, and then open the door.

**FIRST CLOSE THE  
FLAP VALVE**
