Lift up hole RF breakdown

SE-4000 Experimental

2006.06.27 ~ 2006.07.14 Old type cathode block was checked
by high RF voltage bias (up to 8200

Cathode: N4X05 - 2310

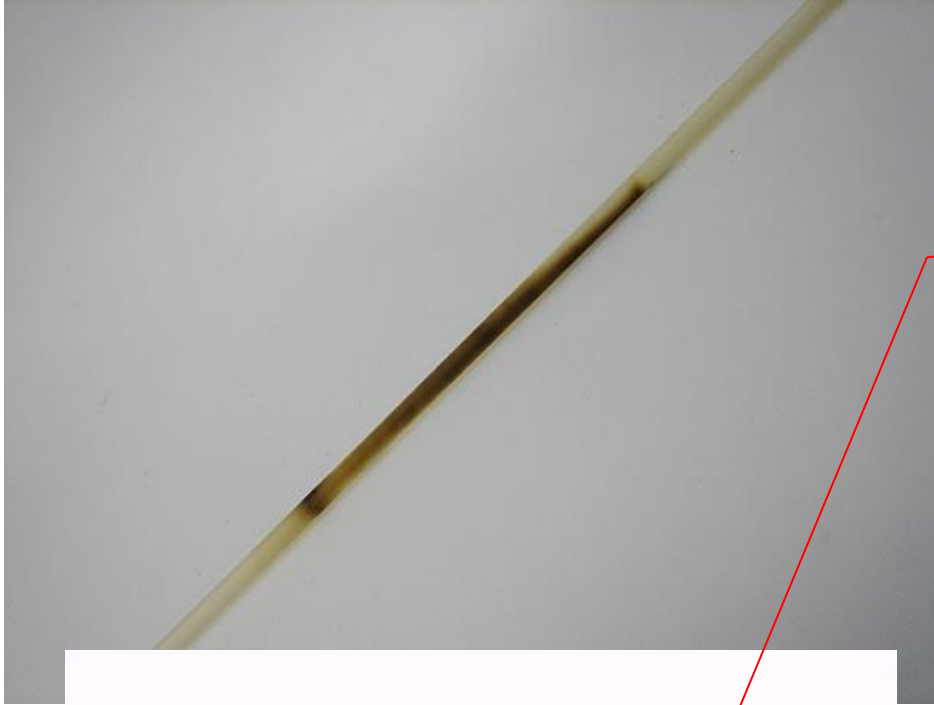
But one lift up hole and lift up pin has traces
of RF capacitive discharge
