# iRADVC7000/9000s

- 1.Coating error
- 2.Coating failure at rear side of sleeve
- 3.Toner leaking

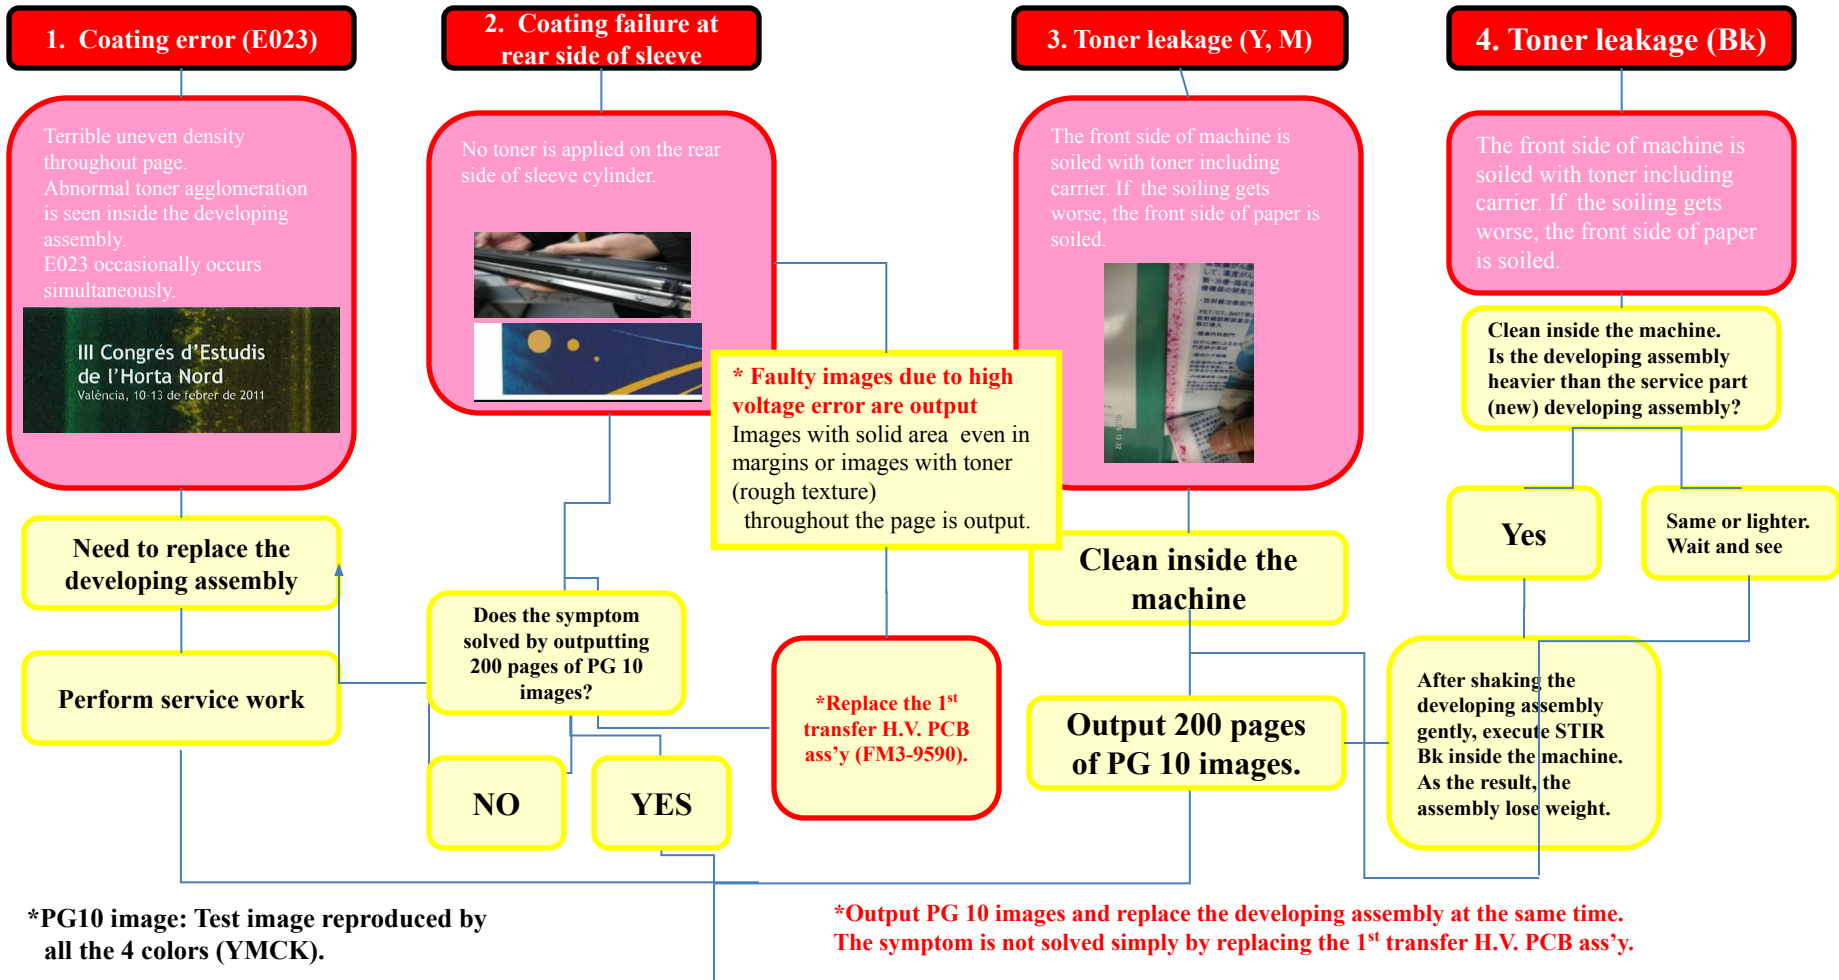
# Service work: Workflow

\*PG10 image: Test image reproduced by all the 4 colors (YMCK).

**A. As the measure against the temperature rise inside the machine, place the machine far away from the wall as much as possible, and replace the 3 filters regularly.**

- Distance between the rear side of machine and the wall: preferably 10cm or more
- Filter (3 filters) replacement intervals: every 500K images
