# THINGS “NOT-TO-DO”

THESE PROCEDURES ARE SUITABLE FOR  
PRIMUS EPIC LOAD 21

**EMBRAER 170/190**

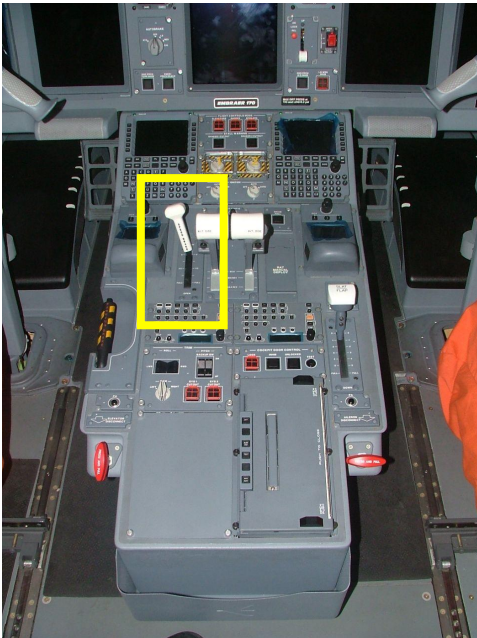
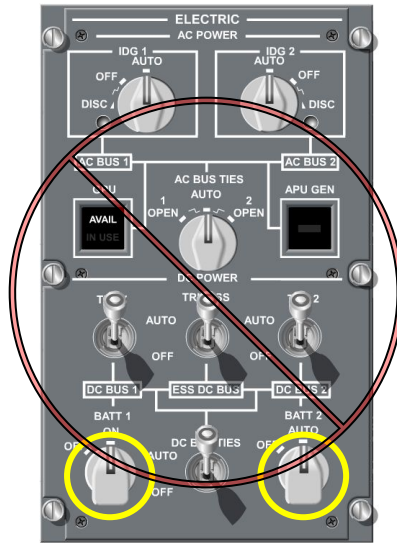
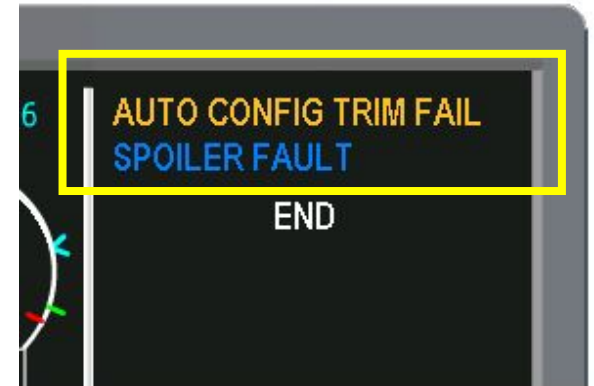
- **DO NOT energize the aircraft with the SF AUTO CONFIG TRIM FAIL of the**
- **LTN RELOADED SPOILER FAULT**
- Note: This is important to avoid that the EICAS messages
- and
- come into view right after the PBIT finish.

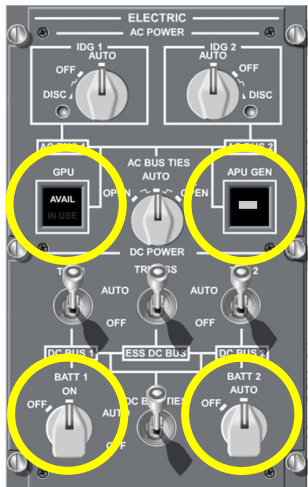
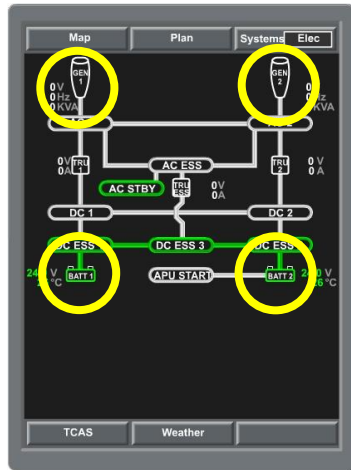
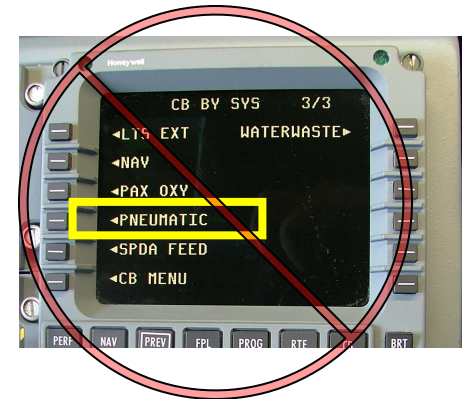
- DO NOT: leave the batteries on for more than 60 s, with GPU or APU GEN off-bus.
- DO NOT: open any AMS SSPCs before any AC source on buses. (GPU/APU/IDG on line)

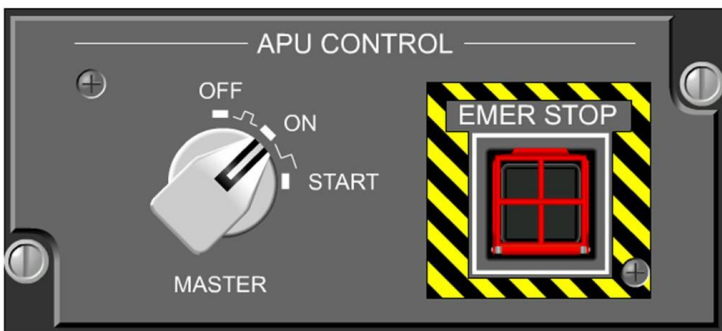
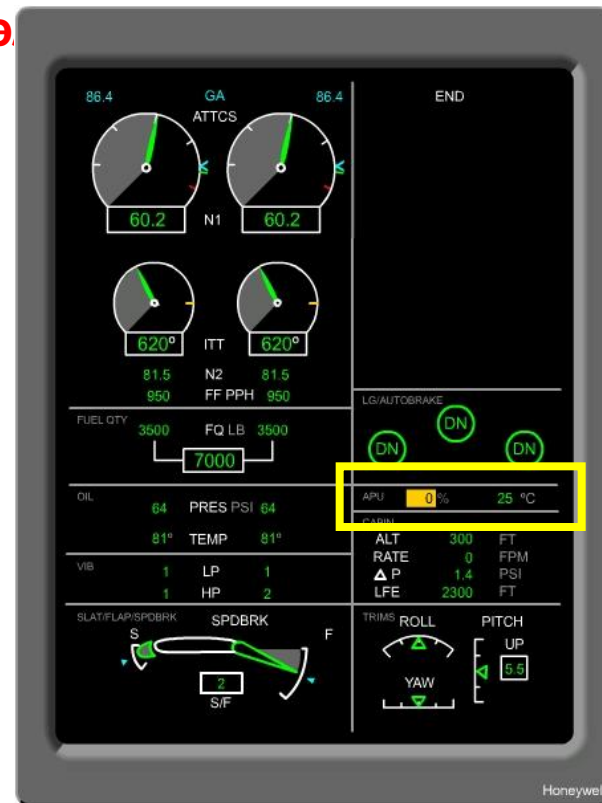
- Note: after selecting the APU master knob to ON, wait until the APU indications come into view on EICAS display.
- After selecting the APU master knob to START position, confirm that the EGT and RPM indications are already presented on EICAS display.**

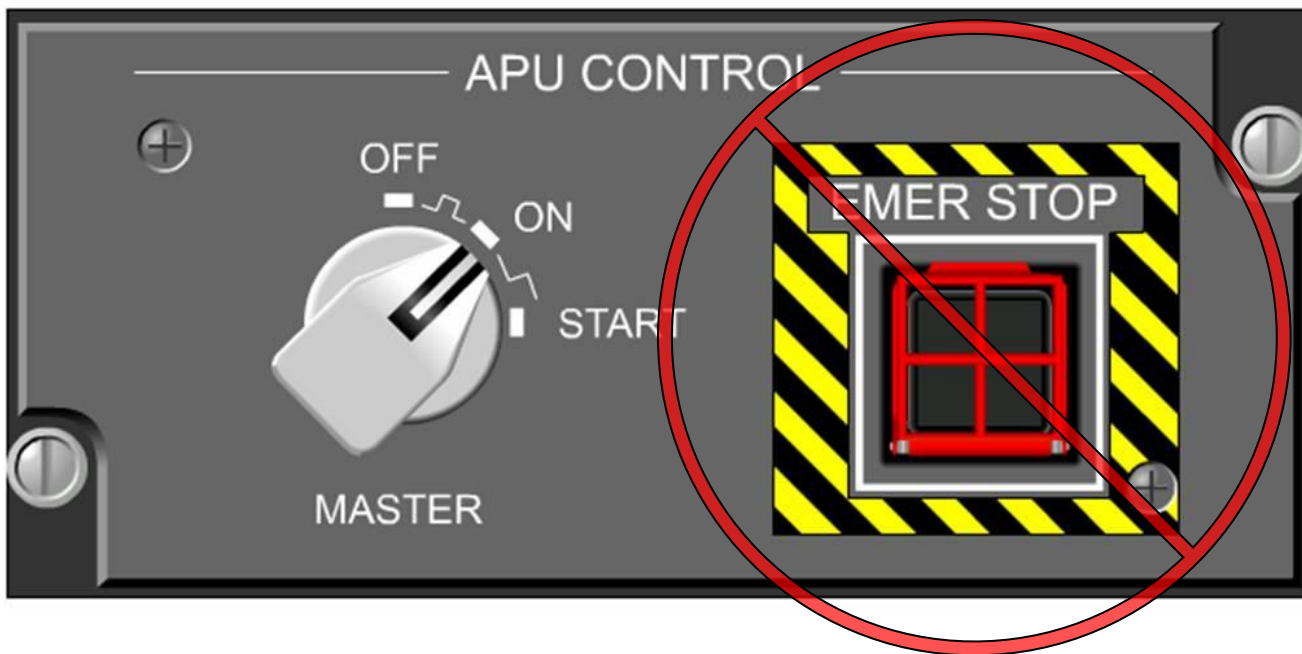
- DO NOT: Shut down the APU using the EMER SWITCH, unless it's ABSOLUTELY NECESSARY.

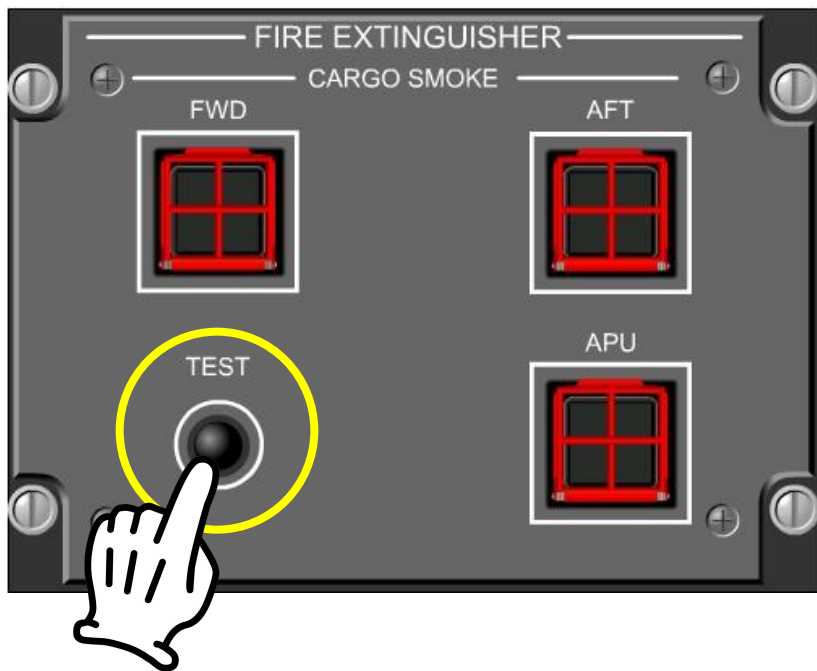
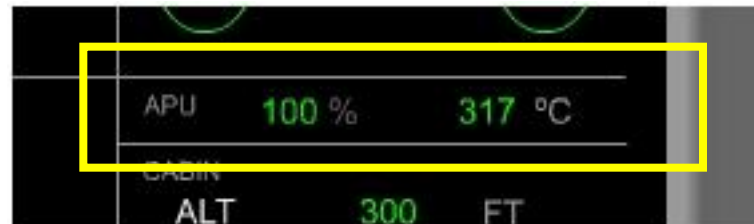
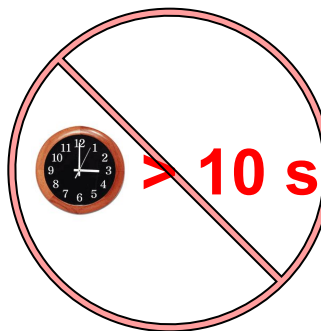
• **DO NOT: Keep the FIRE TEST SWITCH pressed for more than 10s, while the APU is running, otherwise the APU will shutdown.**

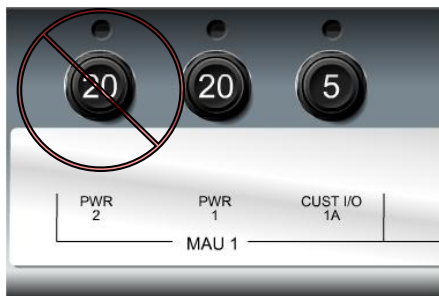
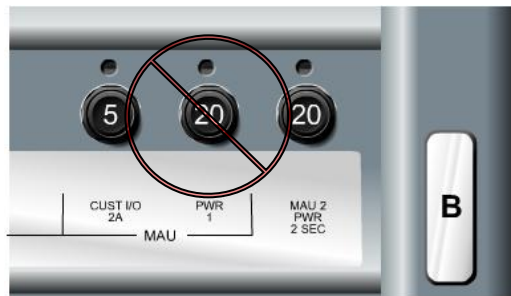
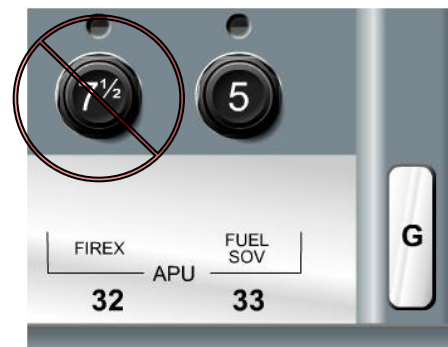
- **DO NOT:** open any SSSPC related to the APU system before APU start, or while APU is running.
- **DO NOT:** open MAU CBs (Generic I/Os #1 and #3) before or after an APU start.
- **DO NOT:** open the APU FIREX CB.

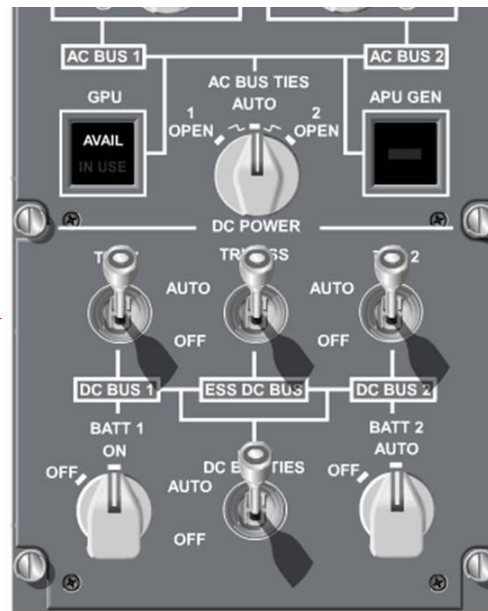
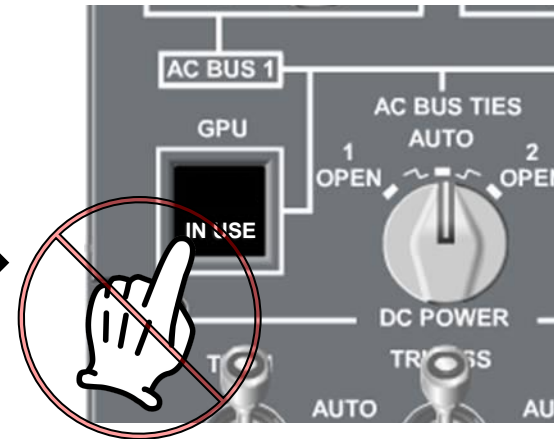
- **DO NOT: set the AC power (APU/GPU) “ON” AGAIN if:**
  - **After the complete power up procedure, the AC buses were de-energized for more than 10s. For instance, in case of a failure on the GPU or APU GEN. Scenario: Batt #1 ON, Batt #2 AUTO and AC power off bus.**
    - Note: With only ESS power available, FCMs lanes B are OFF, and in this case, when hydraulic power is set to ON, a message FLT CTRL NO DISPATCH will be displayed on EICAS.

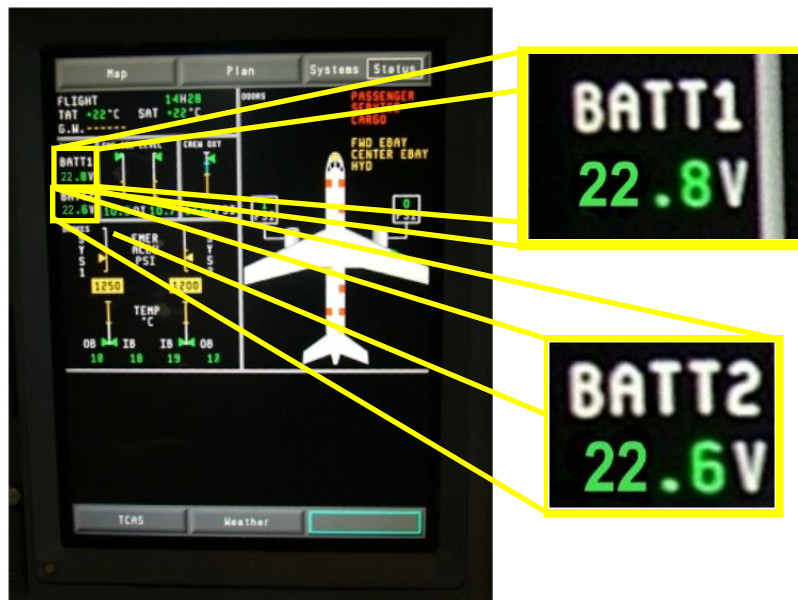
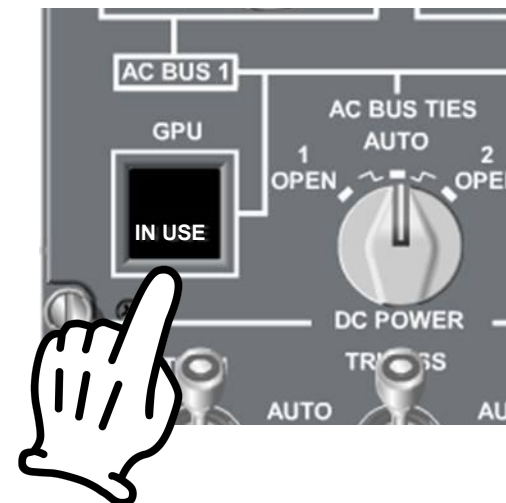
- **DO NOT: set the GPU pushbutton to IN USE before perform the batteries voltage check. (ALWAYS FOLLOW THE POWER UP PROCEDURES)**
  - Note 1: Wait at least 10s between batteries ON and GPU IN USE.
  - Note 2: This always inhibits the flight controls Power-up Built-In Test (P-BIT). If the P-BIT does not run, the message FLT CTRL NO DISPATCH will be displayed.

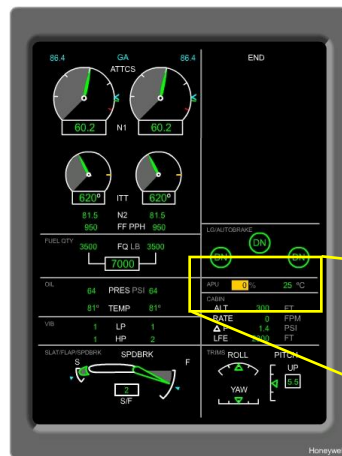
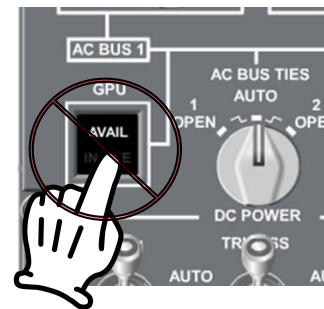
- **DO NOT: Turn off the GPU before the APU indications complete 100% (APU GEN supplying AC network)**
- Note 1: Doing that, a message **FLT CTRL NO DISPATCH** will be presented on EICAS display when hydraulic power is set to ON.
- Note 2: To clear these messages it's necessary to cycle **Flight Control Mode Panel** pushbuttons.

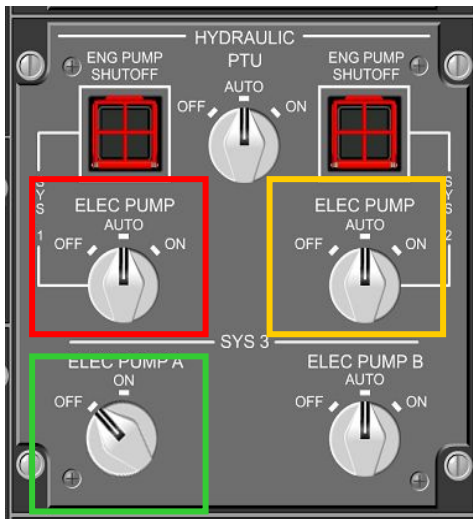
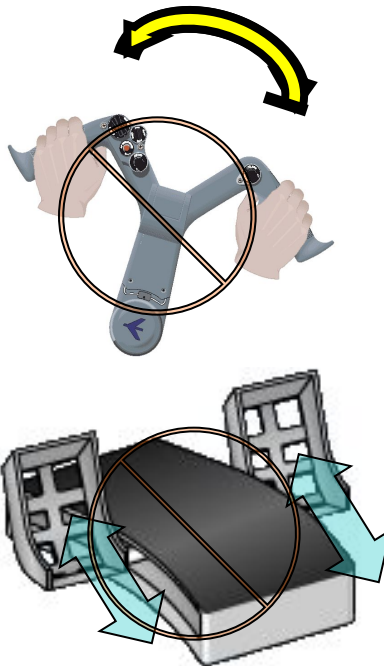
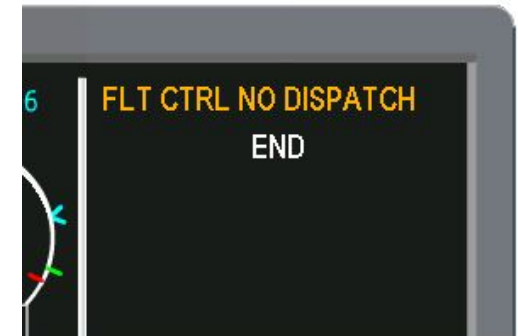
- **DO NOT: actuate the flight control surfaces after turn hydraulic pumps OFF to speed up the hydraulic systems depressurization.**
  - Doing that, the CMC message RUDDER PERFORMANCE FAULT may be presented and it triggers the **FLT CTRL NO DISPATCH** message on EICAS display.
  - To clear the EICAS message, it's necessary to perform the Return-to-Service test.

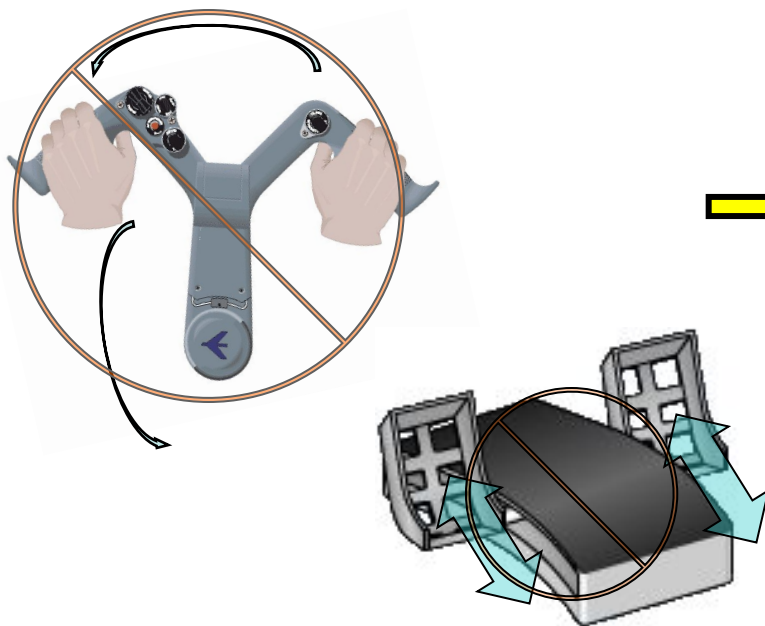
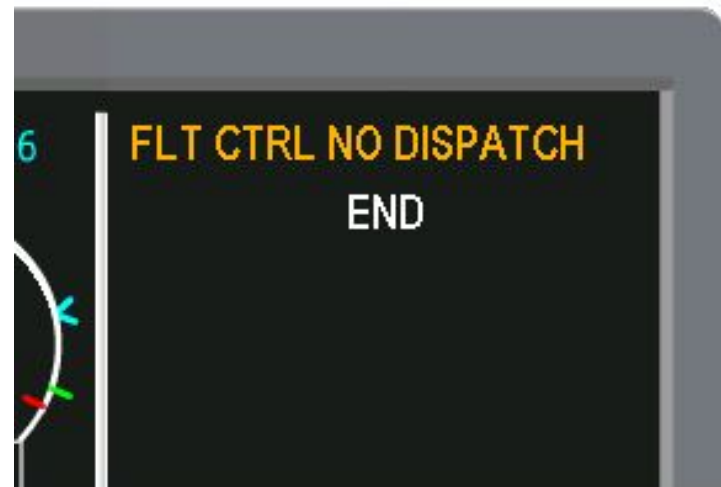
- **DO NOT: actuate more than one flight control surface at a time during the freedom-of-motion test.**
  - Doing that, the CMC message RUDDER PERFORMANCE FAULT may be presented and it triggers the **FLT CTRL NO DISPATCH** message on EICAS display.
  - To clear the EICAS message, it's necessary to perform the Return-to-Service test.
