THINGS “NOT-TO-DO”

THESE PROCEDURES ARE SUITABLE FOR
PRIMUS EPIC LOAD 21

EMBRAER 170/190

THE PURPOSE OF THIS GUIDE IS TO AWARE FLIGHT CREW AND MAINTENANCE STAFF ABOUT THE MOST COMMON REPORTED RAMP MISTAKES

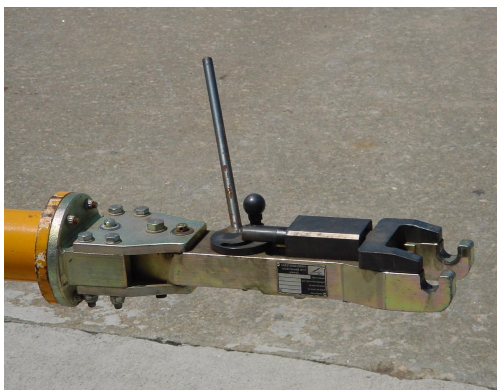
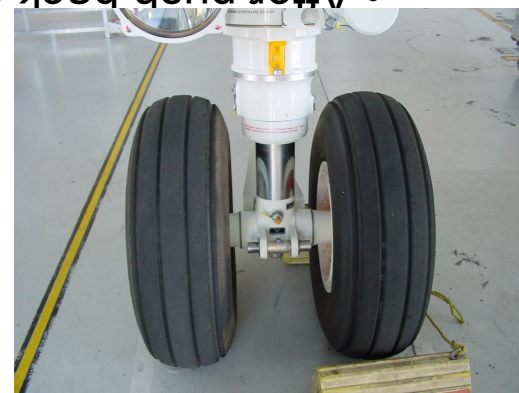
- **DO NOT: set the external STEERING switch to ENGAGE position before disconnect the towbar assy from NLG.**
- Note 1: It could lead the STEER system to a "fail-safe" mode, and the STEER FAIL appears on the EICAS display.
- Note 2: A power reset is necessary to clear the message
- **RIGHT PROCEDURE: Remove the towbar from the NLG, THEN set the STEERING switch to ENGAGE position.**
- After push back or towing procedure is completed:

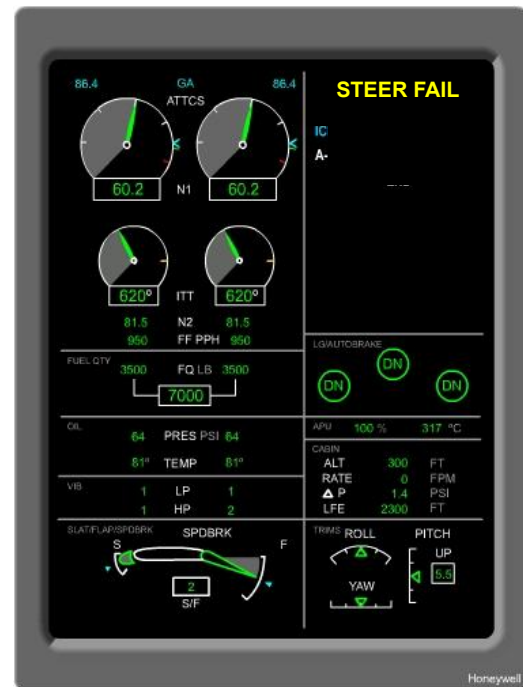
PROCEDURE TO CLEAR "STEER FAIL" MSG ACD SNL AND OB:

ON RIGHT CB PANEL (Co-pilot's side):

MAU 2 PWR 1 CB (B-25).....PULL

MSGs: AVNX MAU 2A FAIL, STEER FAIL, FMS 1 FAIL and AFCS FAULT will be presented on EICAS.

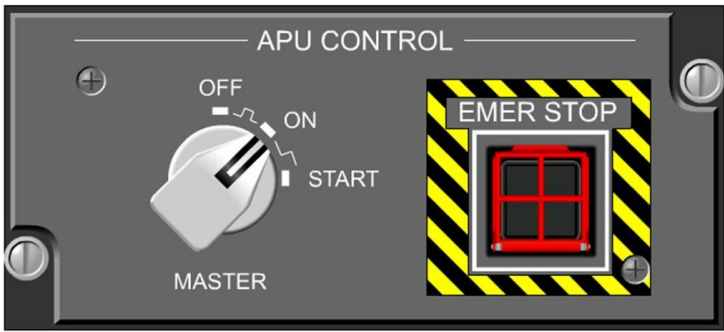
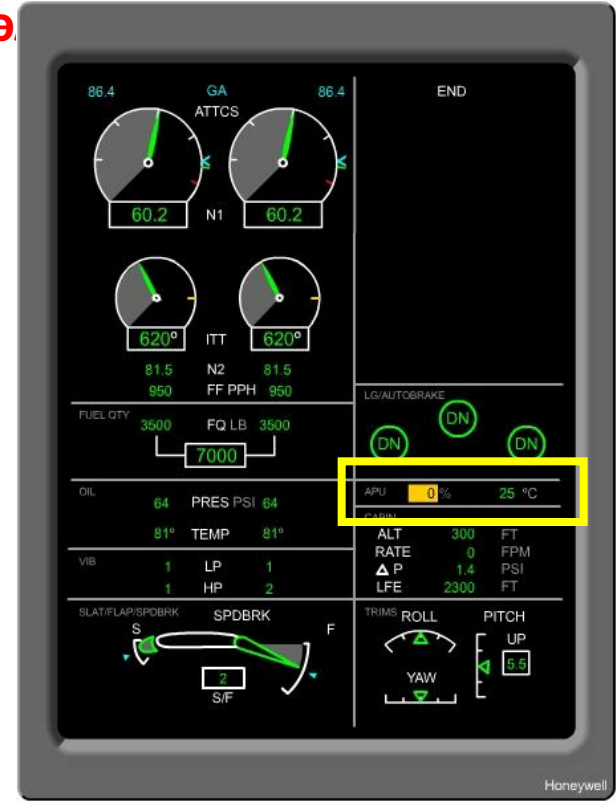
- Note: after selecting the APU master knob to ON, wait until the APU indications come into view on EICAS display.
- After selecting the APU master knob to START position, confirm that the EGT and RPM indications are already presented on EICAS display.**

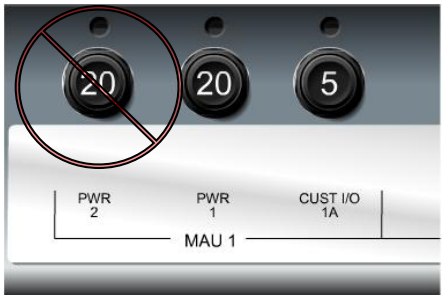
- **DO NOT:** open any SSSPC related to the APU system before APU start, or while APU is running.
- **DO NOT:** open MAU CBs (Generic I/Os #1 and #3) before or after an APU start.
- **DO NOT:** open the APU FIREX CB.

GENERIC I/O #1, MAU #1, LH CB PANEL

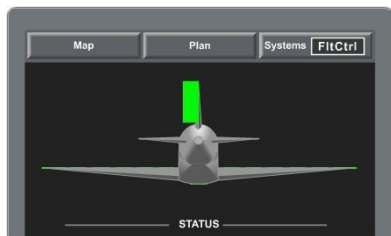
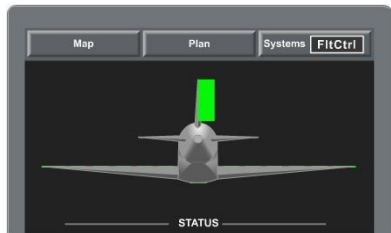
EICAS DISPLAY

- **DO NOT: trim the rudder with the surface deflected while the associated hydraulic systems (#1 and #3) are depressurized.**
 - Note 1: Doing that, a message **FLT CTRL NO DISPATCH** may be presented on EICAS display. An associated maintenance message **RUDDER PERFORMANCE FAULT** (fault code 27030553FCS) may be displayed on CMC active faults.
 - Note 2: In order to avoid this scenario, make sure that the **YAW TRIM** (confirm on EICAS display) is neutral before pressurize the hydraulic systems.

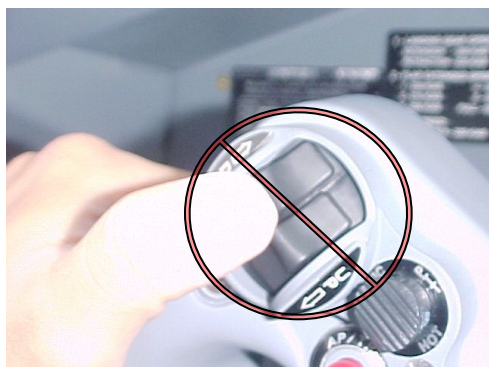
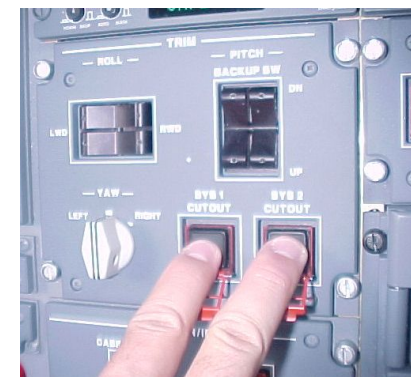
EICAS DISPLAY

- **DO NOT: command only one pitch trim switch.**
- Note 1: Doing that, a message **PITCH TRIM SW 1 FAIL / PITCH TRIM SW 2 FAIL** or **PITCH TRIM BKUP FAIL** will be presented on EICAS display.
- Note 2: To clear these messages it is necessary to cycle both Cut-Out switches.

Effectivity: ON EMBRAER 170/175 ACFT WITH P-ACE PN 7028273-801 according to SNL 170-27-0035 AND ON EMBRAER 190/195 ACFT WITH P-ACE PN 7028273-821 according to SNL 190-27-0027

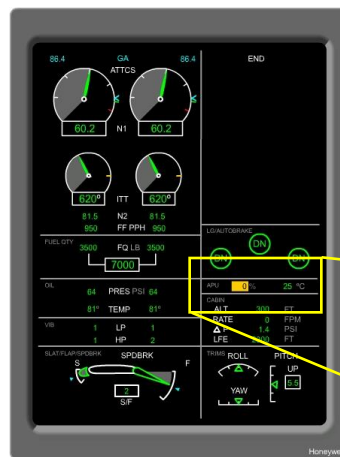
- **DO NOT: Turn off the GPU before the APU indications complete 100% (APU GEN supplying AC network)**
- Note 1: Doing that, a message **FLT CTRL NO DISPATCH** will be presented on EICAS display when hydraulic power is set to ON.
- Note 2: To clear these messages it's necessary to cycle **Flight Control Mode Panel** pushbuttons.

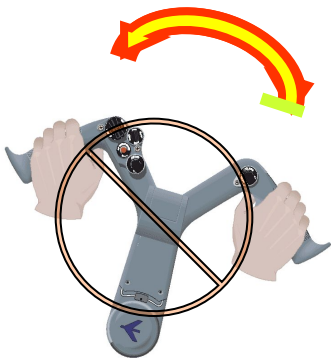
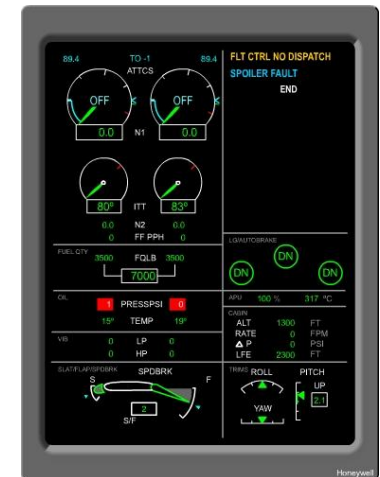
- **DO NOT: cycle the control wheels to speed up the hydraulic systems bleed, with hydraulics 1 and 2 OFF.**
- **Note 1:** Doing that the multi-function spoiler panels may not fully stow, causing a disagreement between the control wheel position and the surface position. If the aircraft is powered down and powered up with any disagreement the message **SPOILER FAULT** will be presented on EICAS display.
- **Note 2:** To clear the SPOILER FAULT message it is necessary to turn **“ON”** the hydraulic systems 1 and 2.

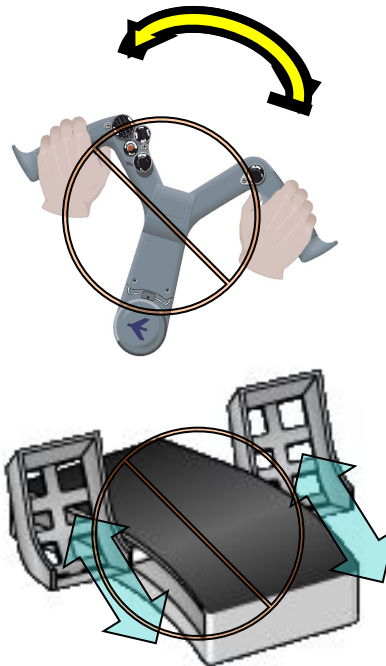
- **DO NOT: actuate more than one flight control surface at a time during the freedom-of-motion test.**
 - Doing that, the CMC message RUDDER PERFORMANCE FAULT may be presented and it triggers the **FLT CTRL NO DISPATCH** message on EICAS display.
 - To clear the EICAS message, it's necessary to perform the Return-to-Service test.

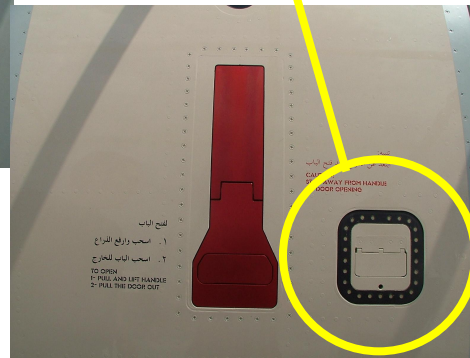
**NOW THE DOOR
CAN BE OPENED**
