Audio

Sephiroth Kwon

26-05-2009

AUDIO

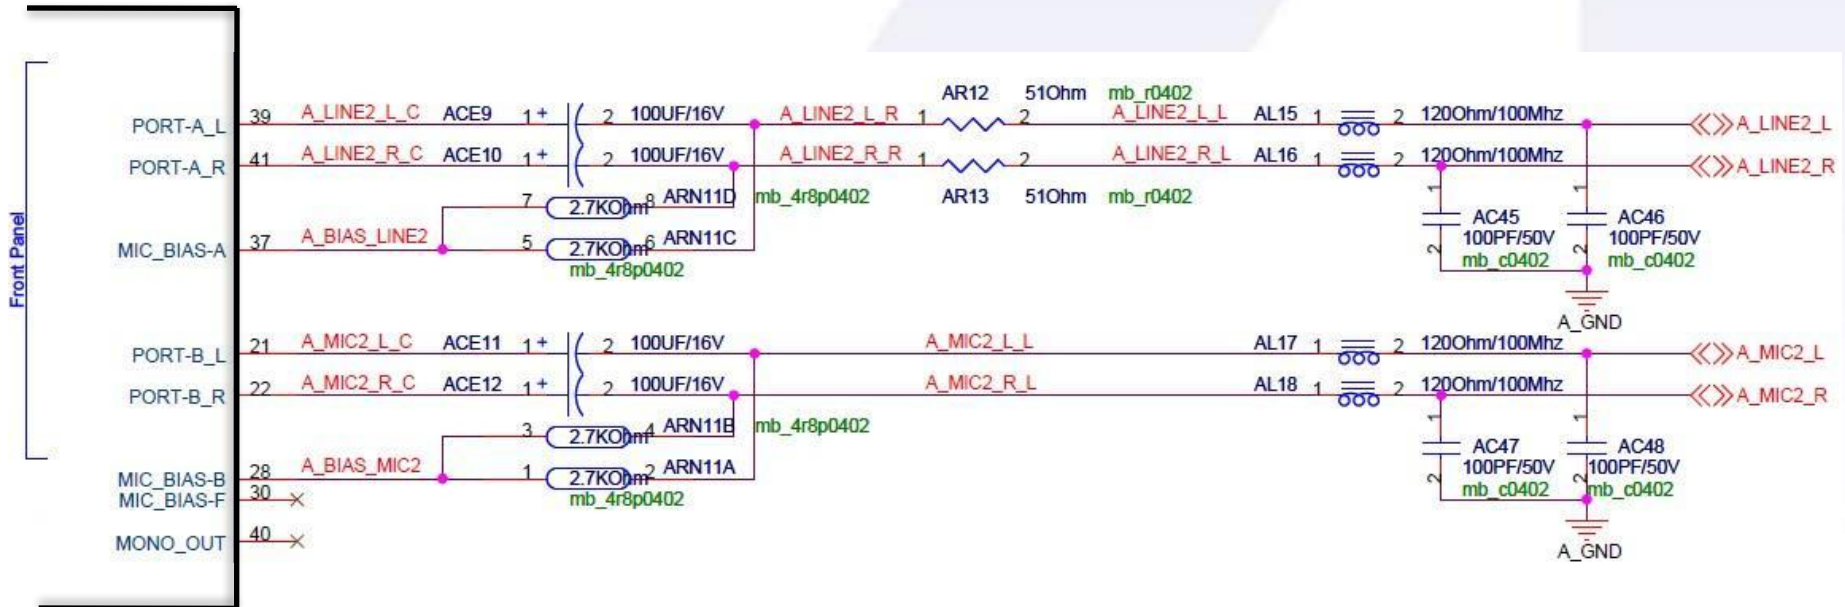
AUDIO(Azalia) Signals Description

Front Panel

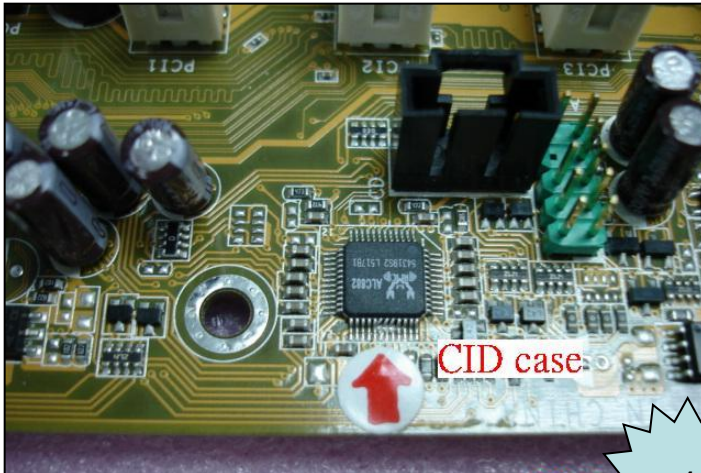
1

Repair Technique-Visual Inspection

Visual Inspection to check Audio connector, Audio chip & nearby related components are not damaged.

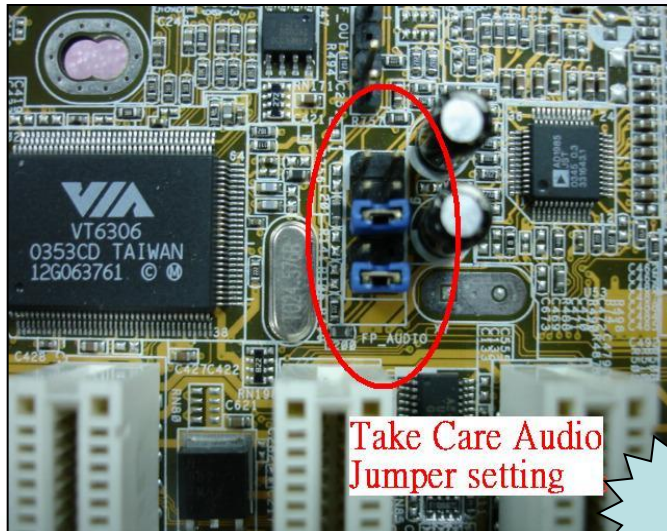
2-2

Make sure **Audio Jumper** is mounted properly.

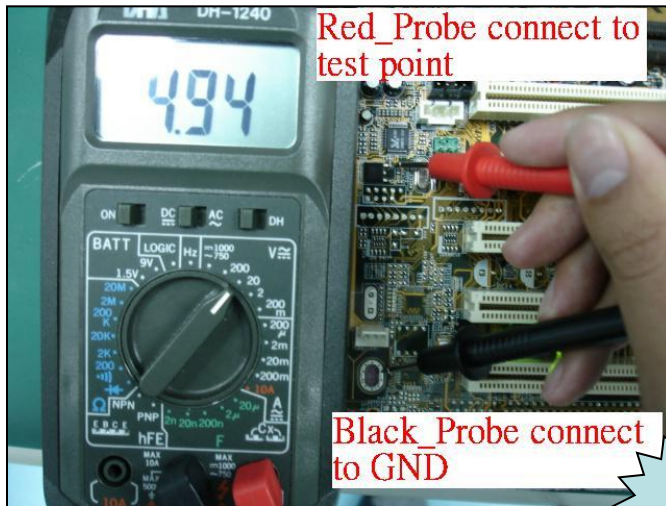
3-1

Use Multi-Meter to measure AUD +5V & 3.3V.

P.S. Audio +5V is transferred by small regulator like 78L05 (+12V to AUD+5V)

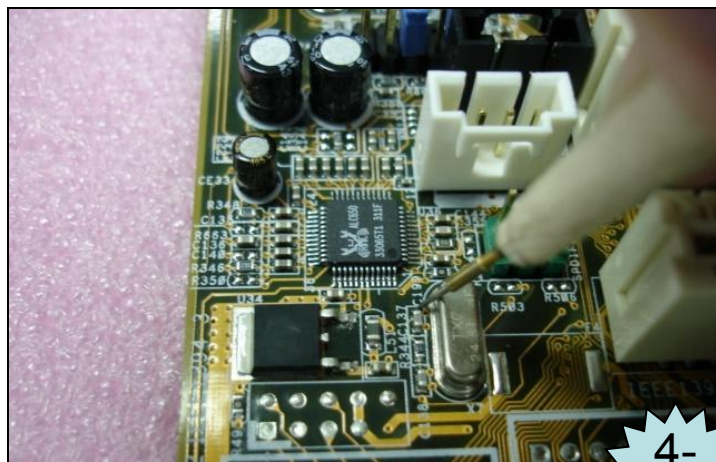
4-1

Use Oscilloscope to measure Audio CLK 24.576Mhz (from X'TAL) or 14.318Mhz (from CLK Generator)

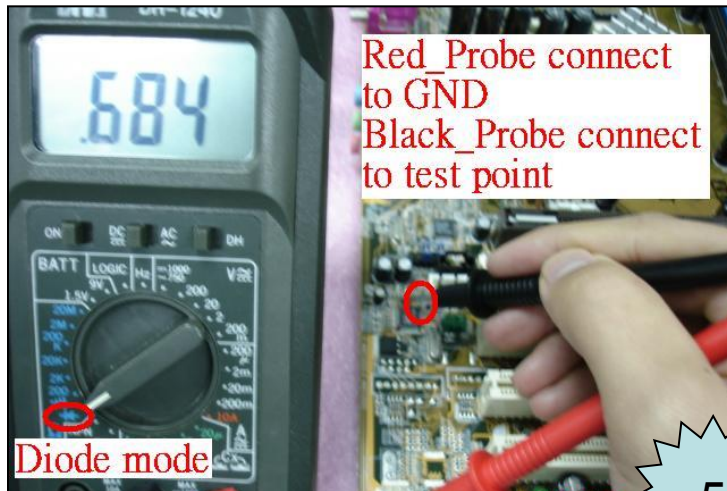
5

Use Multi-Meter to measure other Audio signals' bias voltage value.

(This method should be compared with good MB)

If the symptom is still existing please try to change Audio chip.

After change Audio chip the problem is still constant please try to change SB at last.
